## Preparation of Asbestos Management Plan and Works Oversight

Sierra Leone

**Client: Ministry of Lands, Housing and Country Planning (MLHCP)**

Antea Project Number: INTA250099  
Report INTA250099-2 - Version C of June 29, 2026

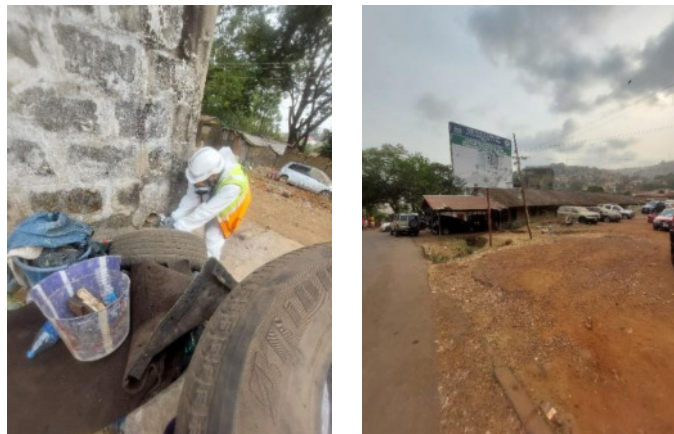
Figure 2. Asbestos survey

- Sheet in fibro cement used as barrier for the garden

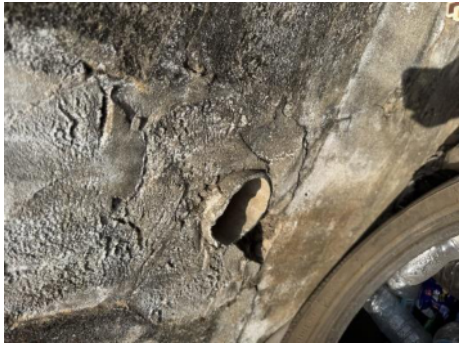
ACM Type	Location			Friability	Physical condition	Likelihood of disturbance	Assigned risk level (high/medium /low)	Criteria used to conclude	Pictures
	Floor	Local	Element						
Pipe	Ground floor	Sanitary building First outing	Bac	Medium	Bad	Medium	Medium	Analysis

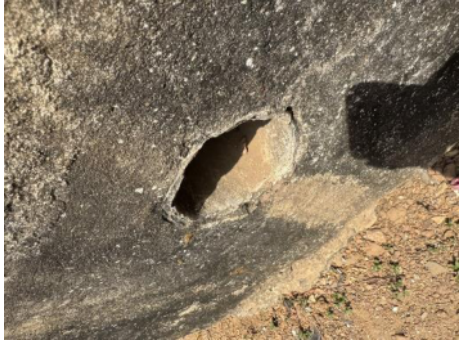
Pipe	Ground floor	Sanitary building 2nd outing	Bac	Medium	Bad	Medium	Medium	Analysis

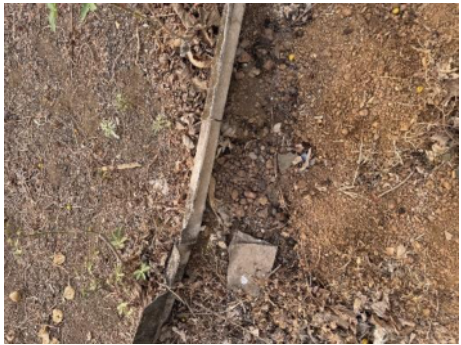
Corrugated sheets	Ground floor	Garden	Plates	Low	Poor conditon	High	High	Analysis

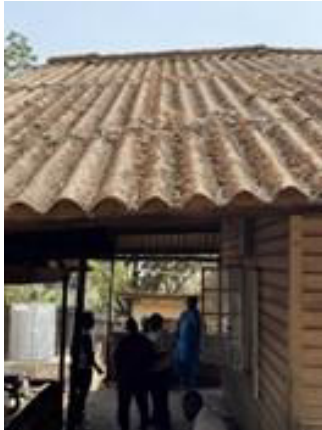
Corrugated sheets	Ground floor	Main building	Roofing and ridge	Medium	Poor conditon	High	High	Analysis

**Note:** as the roofing is bad conditions, there is a high risk to find asbestos dust on the false ceiling. As a consequence, we propose to consider the material as contaminated and managed it accordingly.

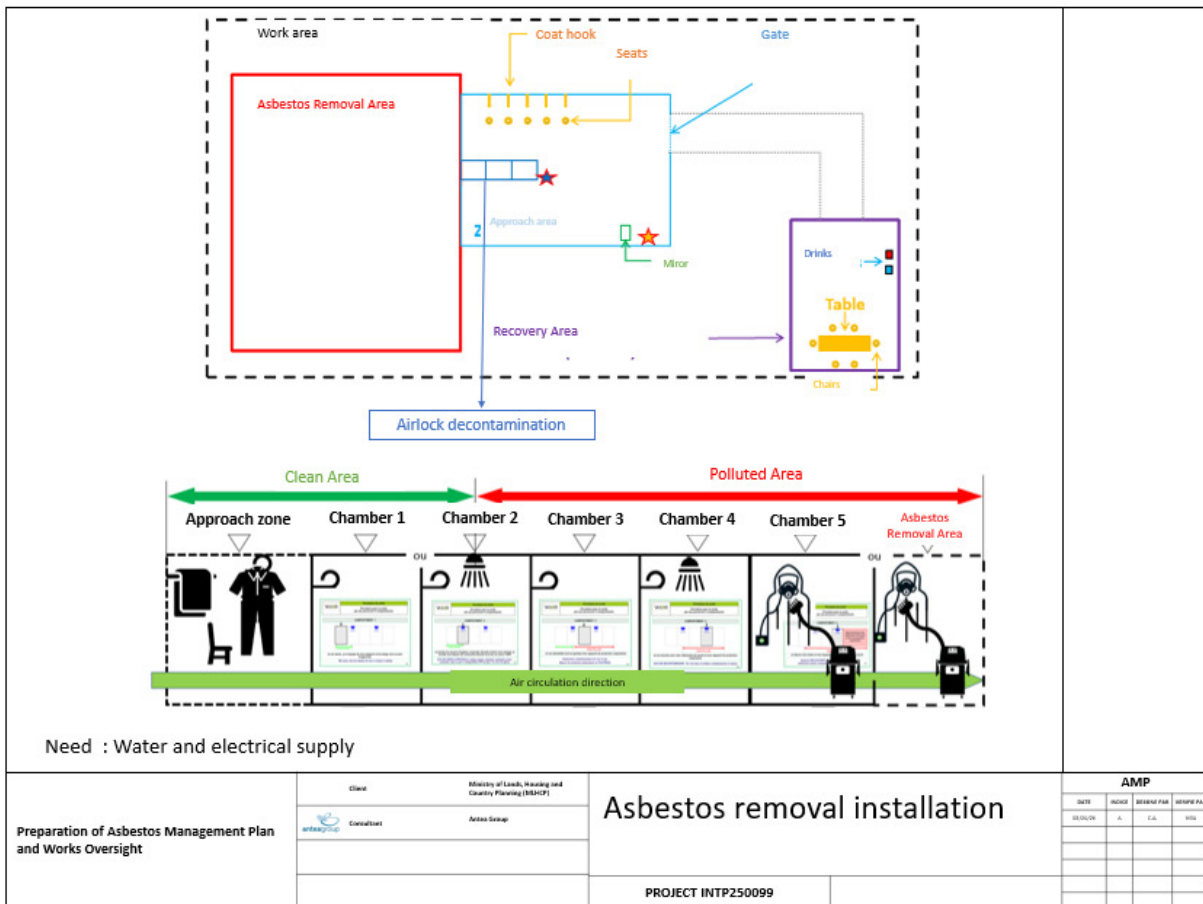
Figure 3. Installation of approach zone & decontamination chamber

The first stage of the asbestos removal project will involve setting up the **approach zone** and **decontamination chambers**. The decontamination chamber must be assembled and the shower system supplied with clean water. The shower water filtration pump must be connected to the shower trays. A discharge point for the filtered water must be selected. A power supply must also be available with several extension cords.

These installations may be placed in the lean-to located in front of the building to be decontaminated.

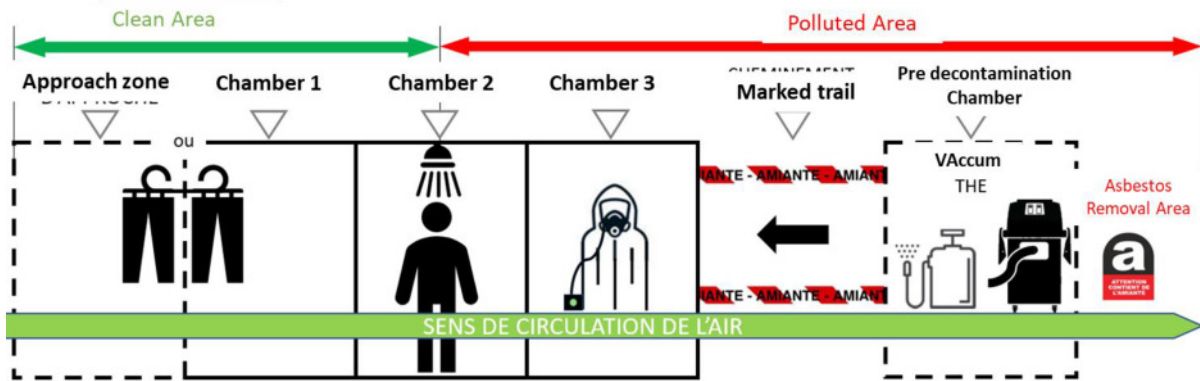
Figure 6. SAS procedure

ZONE EXIT: PERSONNEL AIRLOCK with 1 shower for employees	
Decontamination airlock at the exit of the zone	<ul style="list-style-type: none"> <li>• If warm clothing is worn, it must be thoroughly dusted. It is then stored in a pre-decontamination area for reuse. Otherwise, it will be removed in accordance with the "decontamination procedure for materials and small equipment."</li> <li>• The operator dusts their work clothes using a vacuum cleaner with absolute filtration + brush; They will remove their belt and vacuum it and the coverall. Hard-to-reach areas will be vacuumed by their teammate.</li> <li>• Wetting the coverall using a spray bottle</li> </ul>

<b>Compartment 2:</b> Body hygiene shower	<ul style="list-style-type: none"> <li>The operator showers from head to toe, paying particular attention to the mask straps and hair.</li> <li>He submerges the cartridges in water, then removes them and places them in the waste bag located in compartment 3, reaching through the door flap.</li> <li>They turn off their battery and then remove their respiratory protection. They clean their respiratory protection and hang it on the hook (paying particular attention to the gaps, edges, and handles).</li> <li>They shower with soap.</li> </ul> <p style="text-align: center;"><b>Shower duration: up to 5 minutes</b></p> <p>Notes:</p> <ul style="list-style-type: none"> <li>During the last shift of the day, the last operator to pass through the decontamination facility places their cartridges in a transparent bag, closes it with a swan neck seal, and then places it in compartment 3 by reaching through the door flap.</li> <li>This bag must be returned to the transparent PPE bag during the next shift.</li> <li>The cartridge change and APR decontamination checks are recorded in the <b>exposure dashboard by the airlock operator</b>. The shower time will be monitored by the airlock operator.</li> </ul>

<b>Compartment 1</b> <b>Or</b> <b>Approach zone:</b> Drying and re-dressing	<ul style="list-style-type: none"> <li>The worker dries off and puts on their bathrobe, then goes to the approach area/changing room to put on clean underwear and coveralls or their street clothes.</li> <li>They dry their mask, perform the daily checks, store it in the designated place, and put it on charge.</li> </ul>

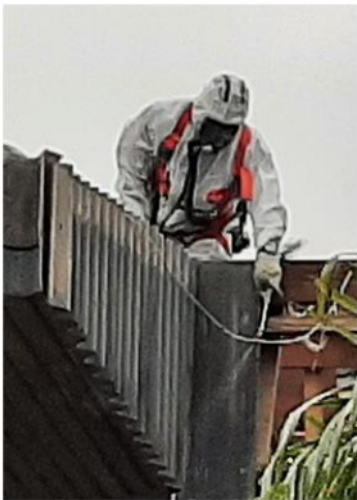
<p>Spraying of surfactant</p>

- Moistening of asbestos-containing materials;
- If asbestos sheets should begin to crack or crumble, immediately wet the cracked or broken areas using a garden pump sprayer;

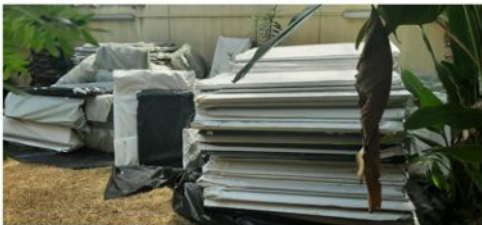
<p>Lifting and sliding of the plate by operator</p>

<p>Packaging and Storage of asbestos</p>																																						
<p>Preparation of Asbestos Management Plan and Works Oversight</p>	<table border="1" style="width: 100%; border-collapse: collapse;"> <tr> <td style="font-size: small;">Client</td> <td style="font-size: small;">Ministry of Lands, Housing and Country Planning (MLHCP)</td> </tr> <tr> <td style="font-size: small;">Consultant</td> <td style="font-size: small;">Antea Group</td> </tr> </table>	Client	Ministry of Lands, Housing and Country Planning (MLHCP)	Consultant	Antea Group	<p><b>Methodology for removing asbestos roofing</b></p>	<table border="1" style="width: 100%; border-collapse: collapse;"> <tr> <th colspan="4">AMP</th> </tr> <tr> <th style="font-size: x-small;">DATE</th> <th style="font-size: x-small;">INDEX</th> <th style="font-size: x-small;">DESCRIPTION</th> <th style="font-size: x-small;">VERSION</th> </tr> <tr> <td style="font-size: x-small;">02/05/20</td> <td style="font-size: x-small;">A</td> <td style="font-size: x-small;">C.A.</td> <td style="font-size: x-small;">001</td> </tr> <tr><td> </td><td> </td><td> </td><td> </td></tr> <tr><td> </td><td> </td><td> </td><td> </td></tr> <tr><td> </td><td> </td><td> </td><td> </td></tr> <tr><td> </td><td> </td><td> </td><td> </td></tr> <tr><td> </td><td> </td><td> </td><td> </td></tr> </table>	AMP				DATE	INDEX	DESCRIPTION	VERSION	02/05/20	A	C.A.	001

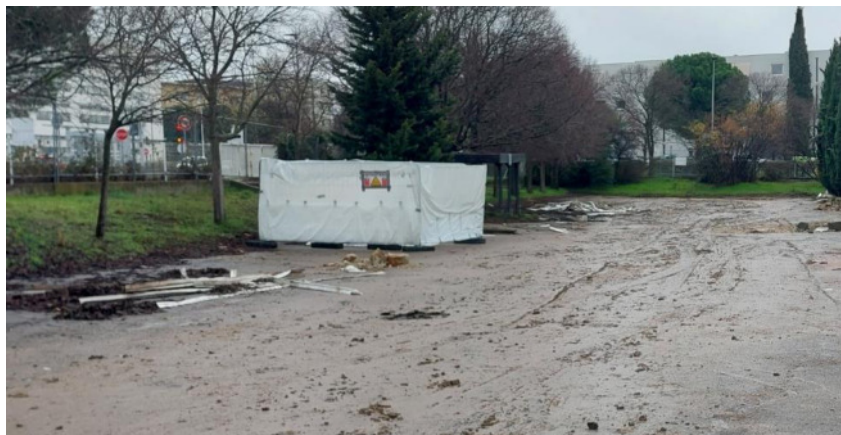
Figure 10. Example of temporary storage of asbestos waste

Signage on the type of waste stored and related risk and contact in case of emergency will need to be displayed at the storage site.

The duration for temporary storage of asbestos waste should not exceed thirty (30) days from the time of removal.

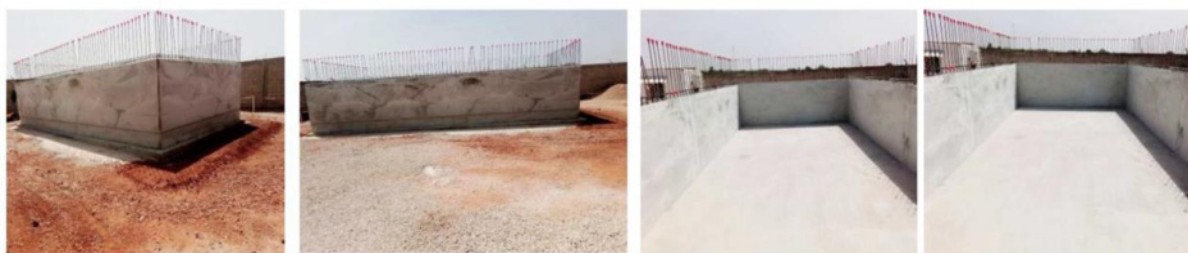
Figure 11. Concrete sarcophagus designed for the safe final storage

Based on the current local capacity on hazardous waste management and feedback from main stakeholders, including the EPA, the final storage of asbestos waste in a concrete sarcophagus can be considered, as proposed by the Client, and located under the construction of future buildings.

It is recommended that this storage is built outside the building's foundations in order to avoid any structural risk to the building. The depth of the sarcophagi shall be as deep as practically possible to accommodate asbestos waste as much as possible but at least one (1) metre above the water table. One or more concrete sarcophagi can be built, depending on the available space and retained scenario (under the building or outside).

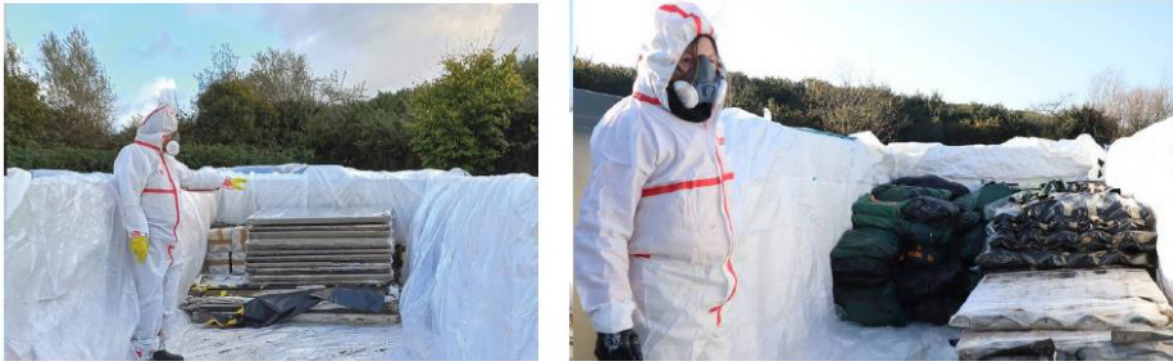
**Figure 12. Storage good practices**

1. Place a double-layer 200 $\mu$  polyethylene sheet at the bottom of the concrete cell;
2. Dispose all available asbestos waste into the concrete cell;
3. Once the concrete cell is full, cover it with 200 $\mu$  polythene sheet and fill the concrete cell with a layer of soil up to the top level of the concrete cell;
4. Fold the polyethylene sheets over the top and place 'asbestos' signage at the top before sealing. In case the cell/sarcophagi is not buried, signage must be placed on the walls;
5. Close the cell with a concrete slab.

The top of the cell must be at least at 1 meter below the ground level.

The polyethylene film to be installed is highly resistant to pressure, tearing (thickness 200 $\mu$ ), and weather conditions (wind, dust, rain, sunlight, etc.), and has a lifespan of between 7 and 8 years. Its mechanical properties (elongation, tensile strength) make it waterproof at all stages of waste handling, ensuring the safety of work areas and the route to the final disposal site (cell).

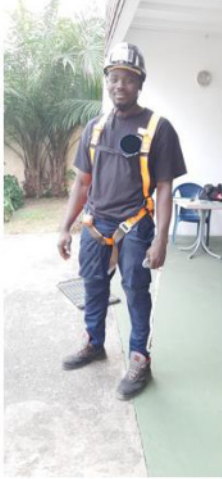
<p><u>harness</u></p>

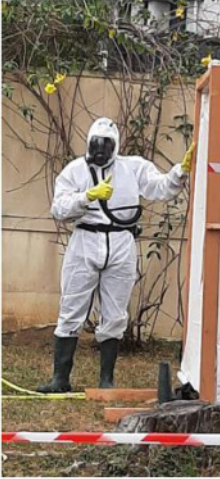
<p>Asbestos <u>specific</u> Equipment</p>

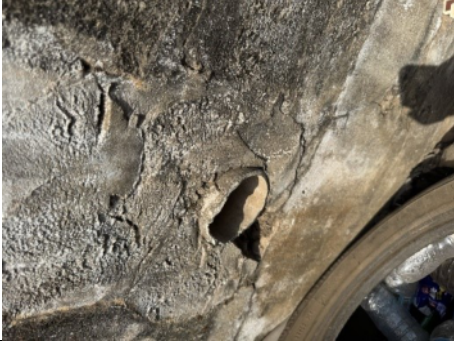
<b>ELEMENT : Conduit</b>		
<b>Location</b>

<b>Customer name</b>	<b>Case number</b>	<b>Part of a work</b>
ANTEA	04 JM2A 2025	Ground floor – sanitary building
<b>Material</b>	<b>Date of collection</b>	<b>Operator name</b>
Fiber cement pipe	25/02/2026	ALBANO Jean Marie
<b>Location</b>		
Conduit 1st exit		
<b>Asbestos result</b>		
<b>Presence of asbestos</b>

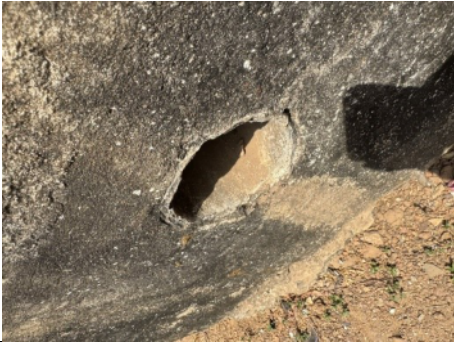
<b>ELEMENT : Conduit</b>		
<b>Location</b>

<b>Customer name</b>	<b>Case number</b>	<b>Part of a work</b>
ANTEA	04 JM2A 2025	Ground floor – Sanitary building
<b>Material</b>	<b>Date of collection</b>	<b>Operator name</b>
Fiber cement pipe	25/02/2026	ALBANO Jean Marie
<b>Location</b>		
Conduit 2nd outlet		
<b>Asbestos result</b>		
<b>Presence of asbestos</b>

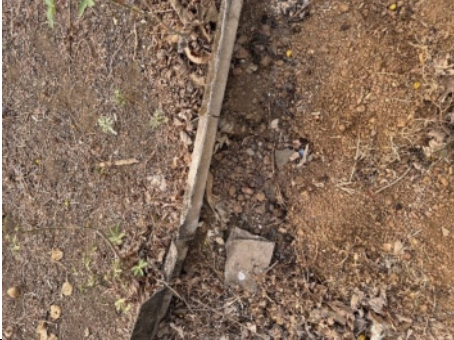
<b>ELEMENT : Garden</b>		
<b>Location</b>

<b>Customer name</b>	<b>Case number</b>	<b>Part of a work</b>
ANTEA	04 JM2A 2025	Ground floor - Garden
<b>Material</b>	<b>Date of collection</b>	<b>Operator name</b>
Corrugated sheets - Raw	25/02/2026	ALBANO Jean Marie
<b>Location</b>		
Garden		
<b>Asbestos result</b>		
<b>Presence of asbestos</b>

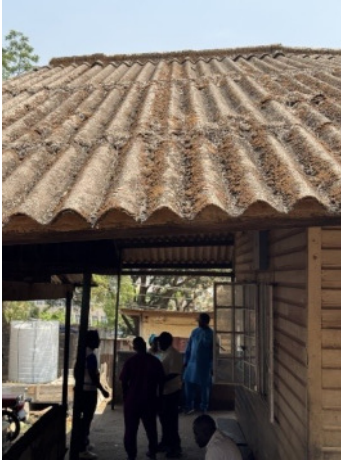
<b>ELEMENT : Roofing and ridge</b>		
<b>Location</b>

<b>Customer name</b>	<b>Case number</b>	<b>Part of a work</b>
ANTEA	04 JM2A 2025	Ground floor – Main building
<b>Material</b>	<b>Date of collection</b>	<b>Operator name</b>
Corrugated sheets - Raw	25/02/2026	ALBANO Jean Marie
<b>Location</b>		
Roofing - Roofing		
<b>Asbestos result</b>		
<b>Presence of asbestos</b>

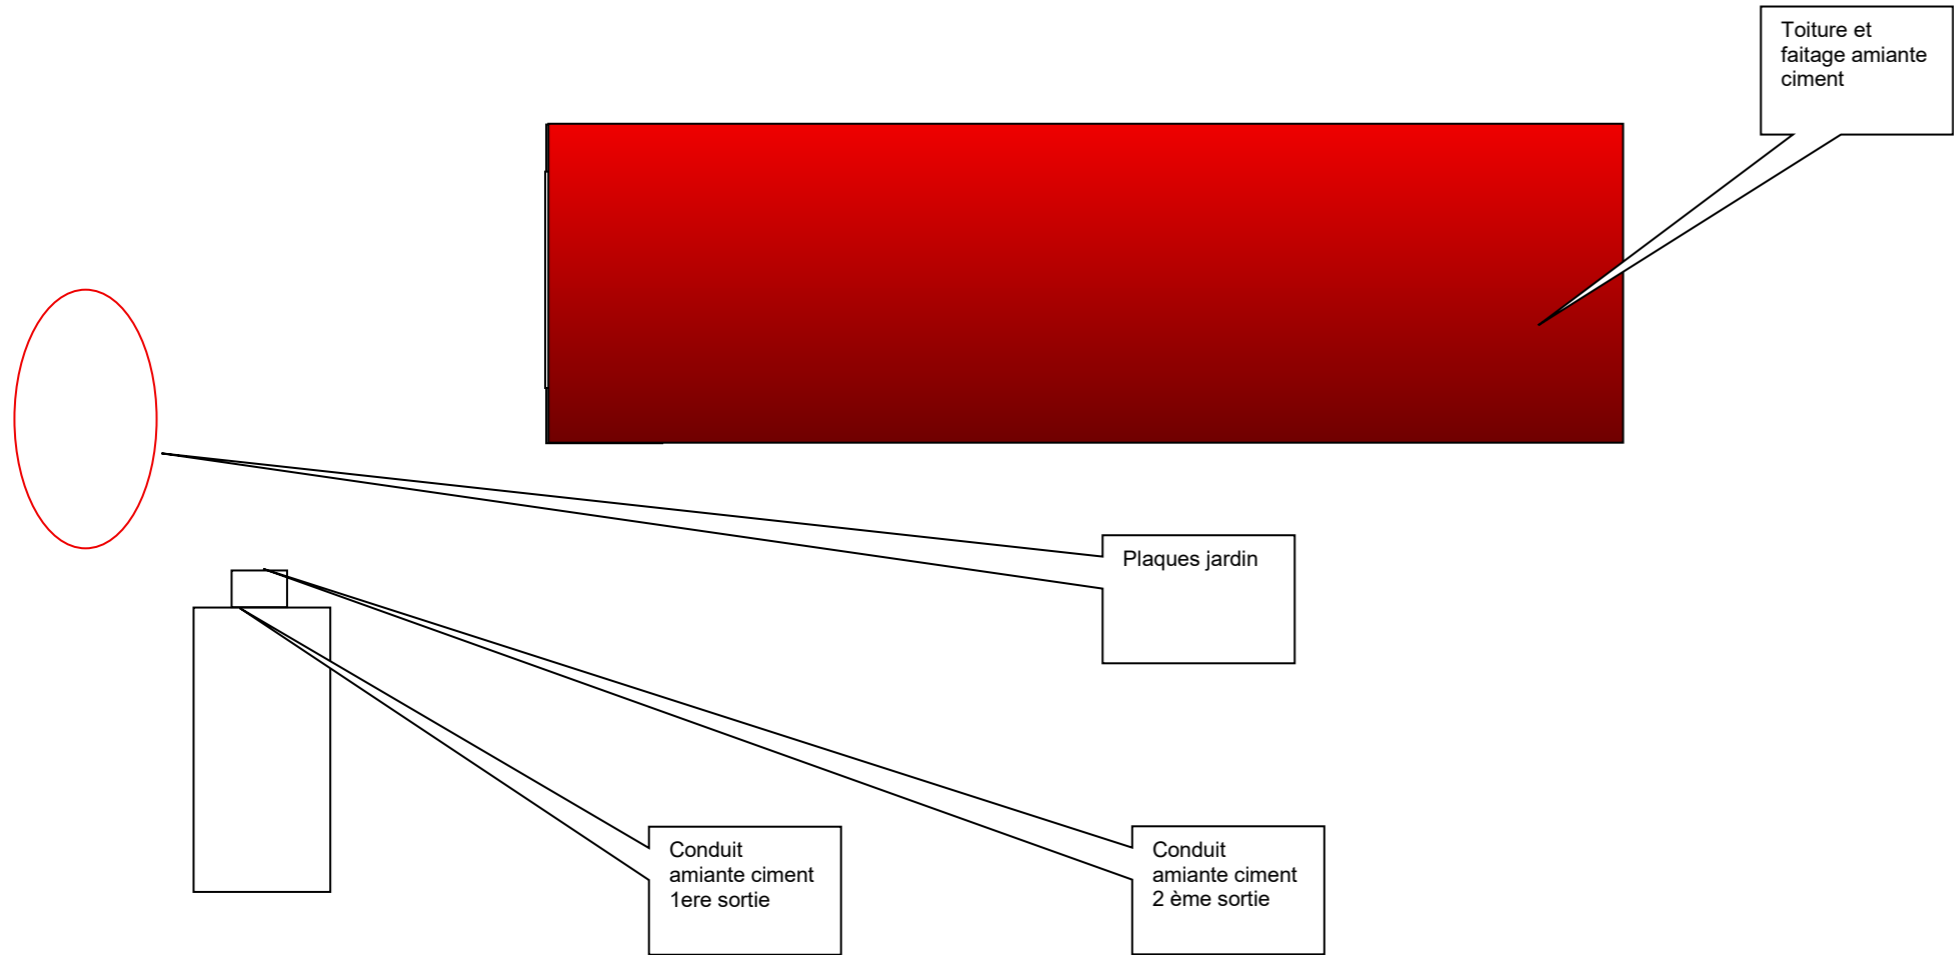
**APPENDIX SKETCH**

Location chart			
Customer :	ANTEA	Title :	Sketch No. 1
Report No.:		Location of intervention:	Freetown Sierra Leone Offices
Plate number:	1/1		
Kind :	Standard layout diagram		
Date :	25/02/2026	Building :	Building to be demolished
Speaker:	ALBANO Jean Marie	Floor :	Ground Floor
Origin of the plan:	Sketch or document transmitted	Comment :	Freehand sketch without dimensions

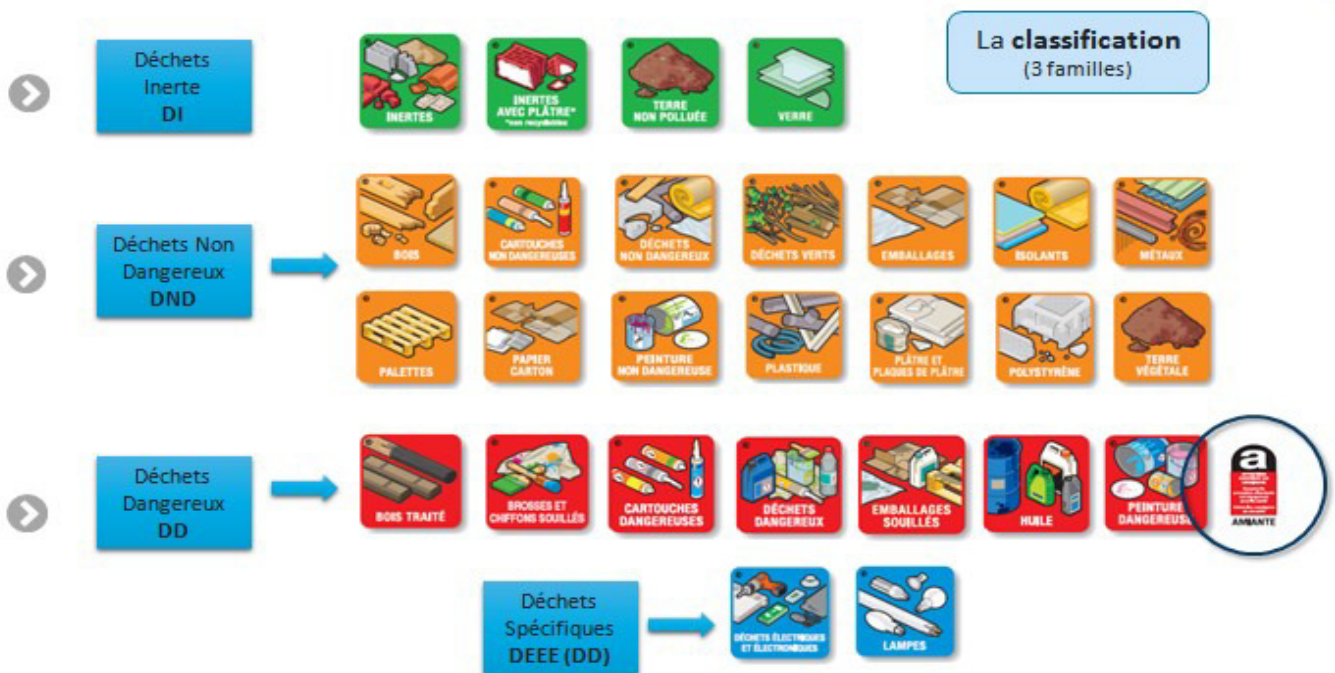
Waste families

The different types of asbestos waste

Asbestos waste is divided into two main categories with regard to disposal management. The treatment **will depend on the nature of the asbestos waste.**
